Report No. 8926-156

Corrosion Evaluation, Service Items

REPORT NO. MP-61-139

# CORROSION EVALUATION OF F-102 WING ACCESS DOORS

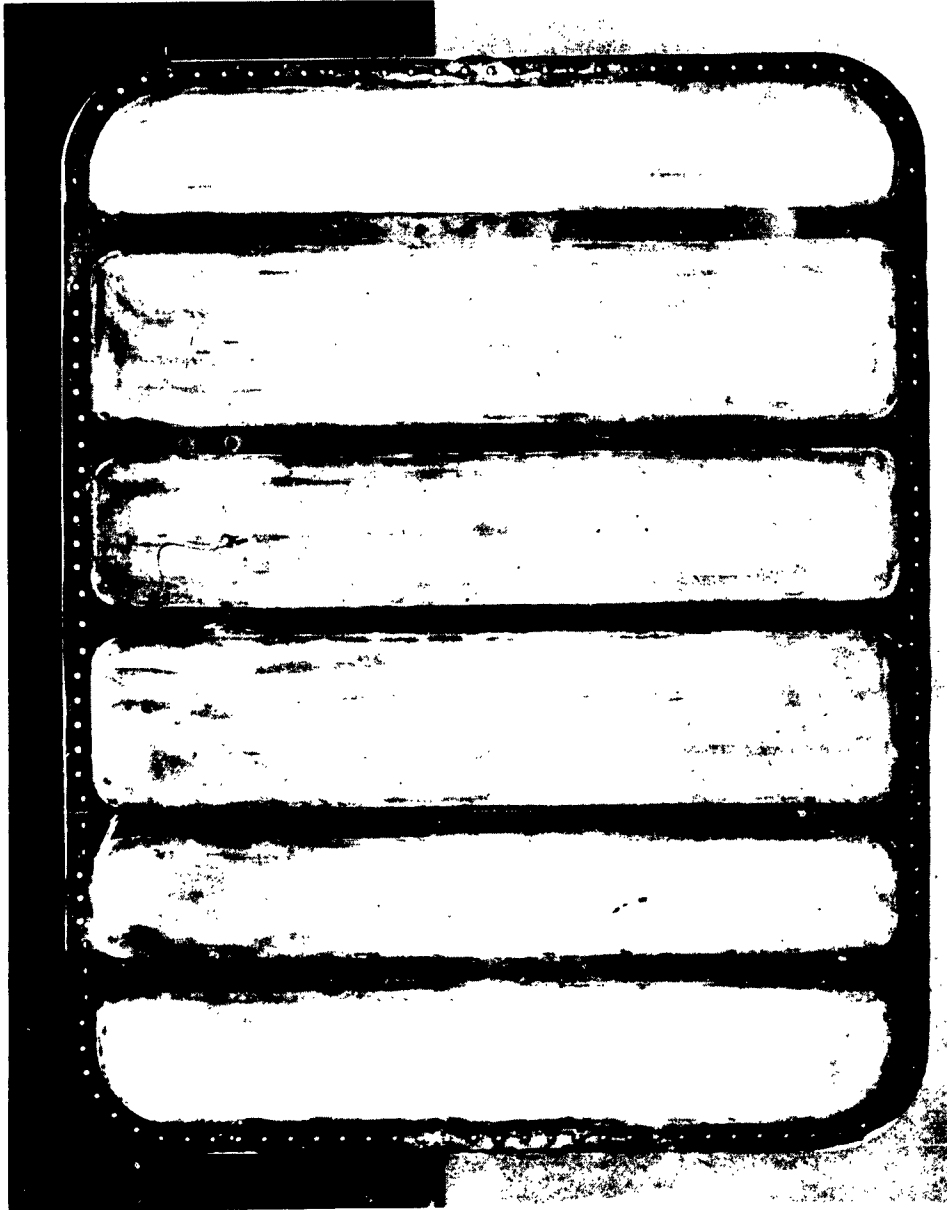
A photograph of the door date stamped January 19, 1956 is shown in Figure 1. A photograph of the most corroded section of the same door is shown in Figure 2. A photograph of the door date stamped March 12, 1956 is shown in Figure 3. The most corroded section of the same door is shown in Figure 4. The corroded areas of both doors were examined microscopically. Sections were removed from the most severely attacked door to evaluate for susceptibility to intergranular corrosion. The EC-1290 Scotchweld primer on the door was evaluated for degree of cure by comparing its resistance to methyl ethyl ketone wipe with that of properly applied and cured EC-1290 control coating. The depth of the pits was determined by a Micrometer.

FIGURE 1. F-102 WING ACCESS DOOR DATE STAMPED JANUARY 19,1956.
